CARL SWAINSTON ARCHITECTURAL  
Structural and Civil Engineer  
24 Walker Drive Bishop Auckland Co Durham  
DL14 6QW

## Structural Appraisal - Woodland Village Non Denominational Chapel of Rest Woodland Co Durham

For Mr Simon Land Curator  
Date: 17/01/24

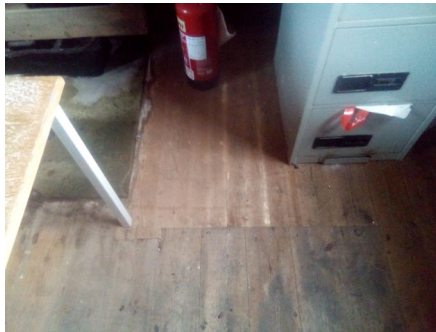
1. Ground floor boarding – evidence of wood boring insect infestation

Defect rating - Low risk

Wood dust on flooring

Action – treat area with a good quality insecticide and wood preserver.

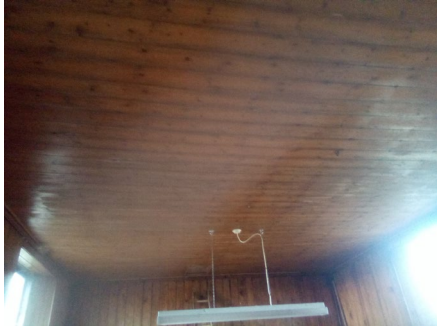
2. Ceiling – Ceiling sagging at mid span

Probable cause – ceiling joists over spanned

Defect rating – Medium risk if untreated

Significant sag in ceiling

Action – remove ceiling and investigate Part A in terms of size of rafters and ceiling joists

It is recommended that the ceiling be removed completely and the roof line be the new ceiling i.e. to act as a vault, this will automatically remove one defect and relieve stress at the eaves.

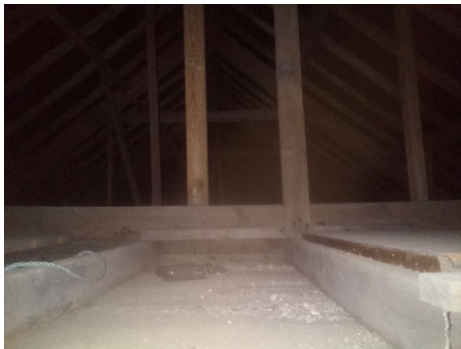
### 3. Roof void – new roof structure causing rear wall to spread outward

Probable cause – inadequate raised tie trusses or weight of ceiling causing overstressing at eaves

Defect rating – Medium risk if left untreated.

Ceiling supported by raised tie trusses

Action – calculate roof loads and check span of rafters to ascertain if the roof structure is adequate.

It is recommended that the structural engineer design a braced roof to comply with Part A of the Building Regulations 2013.

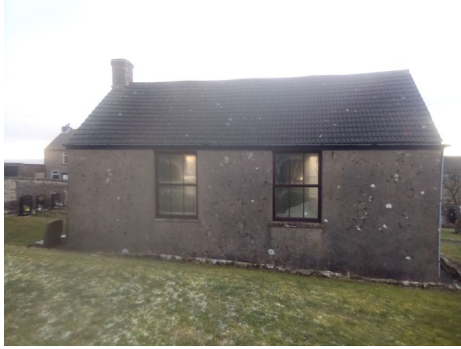
The roof ridge line seems to be uneven suggesting that deflection in some of the roof structure has taken place. This is also seen in the wall panel between the two rectangular windows which has a significant lean outwards or out of plumb shift of 60mm over the length of the 1.8m level.

Ridge line uneven

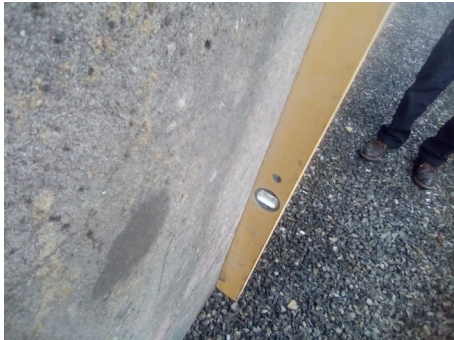
1. Rear elevation wall panel between windows – 60mm out of plumb shift over 1.8m.

Probable cause – roof spread due to overstressing of roof trusses

Defect rating – High risk if left untreated.

Out of plumb shift

The wall lean can only be arrested not returned to its original position due to the length of time it has taken to lean over.

Action – re-assess the roof structure and fit roof straps as lateral bracing

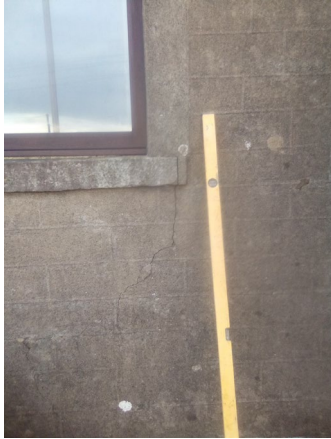
2. Front window – crack at cill level

Probable cause – Local differential settlement

Defect rating – Low risk

Crack at window cill

Action – re-point affected area
