Safety Inspection Report

Annual Inspection

Woodland Playground

17 June 2026

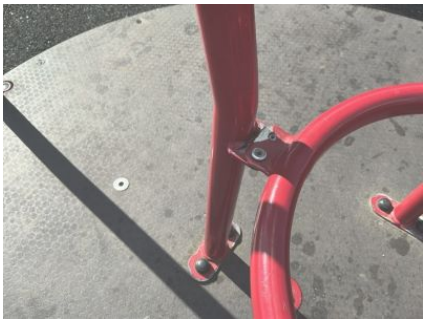
Additional comments are noted below.

Broken rivets. Replace.

Read the notes for further action.

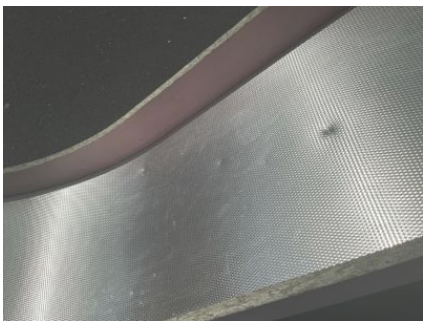
The slide chute is showing signs of damage.

No reasonably practicable action is identified.
